Final Report Compilation for
Whole Building Diagnostician
Demonstration

TECHNICAL REPORT

October 2003
P-500-03-096-A4

CALIFORNIA ENERGY COMMISSION

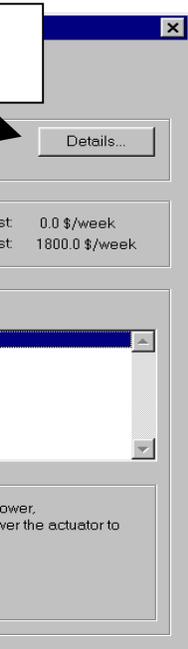
Figure 6 – Window Showing a Description of the Diagnosis, the Impacts of the Problem Found, Potential Causes of the Problem, and Suggested Corrective Actions.

Figure 6 and Figure 7 show pop-up windows providing a short description of a problem, a more detailed explanation of the problem, energy impacts of the problem, potential causes, and suggested actions to correct each cause. The second window (Figure 7) labeled "Details" is revealed by "clicking" on the "Details" button in the first window (Figure 6). In this case, the problem investigated is a sensor problem. The current version of this OAE diagnostician cannot, by itself, isolate the specific sensor that has failed, but instead it suggests manual inspection and testing of the sensors and their wiring to identify the specific problem. Yet another example of OAE is shown in Figure 8, where a high energy consumption problem is evident.

Figure 6 – Window Showing a Description of the Diagnosis, the Impacts of the Problem Found, Potential Causes of the Problem, and Suggested Corrective Actions.

Figure 6 and Figure 7 show pop-up windows providing a short description of a problem, a more detailed explanation of the problem, energy impacts of the problem, potential causes, and suggested actions to correct each cause. The second window (Figure 7) labeled "Details" is revealed by "clicking" on the "Details" button in the first window (Figure 6). In this case, the problem investigated is a sensor problem. The current version of this OAE diagnostician cannot, by itself, isolate the specific sensor that has failed, but instead it suggests manual inspection and testing of the sensors and their wiring to identify the specific problem. Yet another example of OAE is shown in Figure 8, where a high-energy consumption problem is evident.
